**Ernest Orlando Lawrence
Berkeley National Laboratory**

**Air Corrosivity in U.S. Outdoor-Air-Cooled Data Centers is
Similar to That in Conventional Data Centers**

Part of the DOE Roadmap for Compressorless Cooling in Data Centers

March 2011 Rev.

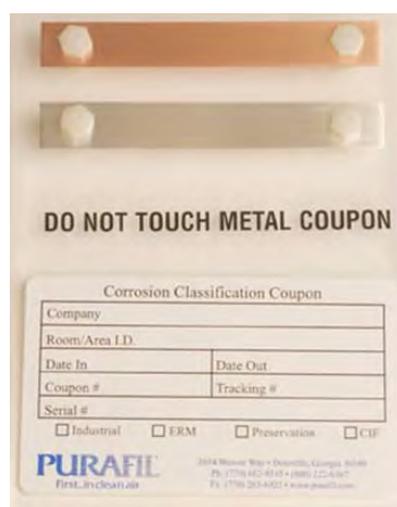
Figure 1 – Unexposed Corrosion Classification Coupon Containing Copper and Silver Metal Strips

The use of metal coupons is the best known and simplest of all corrosion monitoring techniques. At least two companies offer coupons and the required analysis; we selected Purafil. The method involves exposing a coupon specimen to the environment for a given duration (e.g. 30 days). Following exposure, the specimens were analyzed. The magnitude of corrosion film, or corrosivity, was quantified by corrosion growth rate as angstroms (\AA)/30 days. In addition the analysis can provide some information regarding what type of contaminate was the likely caused of most of the corrosion growth. Under the scope of this project, the research team was not able to analyze this information, but the data is available and this type of analysis is recommended for future studies. Each coupon set (copper and silver) is attached to a Plexiglas support (approximately 4" x 3" x 1/4") and coupon number, date, and location information recorded on the transmittal label (Figure 1). In order to minimize any background corrosion, coupons are provided packed in a zip-lock plastic bag with a Purafil Sachet that acts as a scavenger for any ambient contamination that may have been sealed inside the bag with the coupon. After the exposure period the coupons are repackaged in the original plastic bag with the Sachet and returned for analysis.

The standard method for analyzing corrosion coupon is called cathodic/electrolytic reduction. The thickness of the corrosion film is determined by Purafil's laboratory analysis. The results of the report included a photograph of the returned coupon, ISA Environmental Classification, and film thickness/30 days.

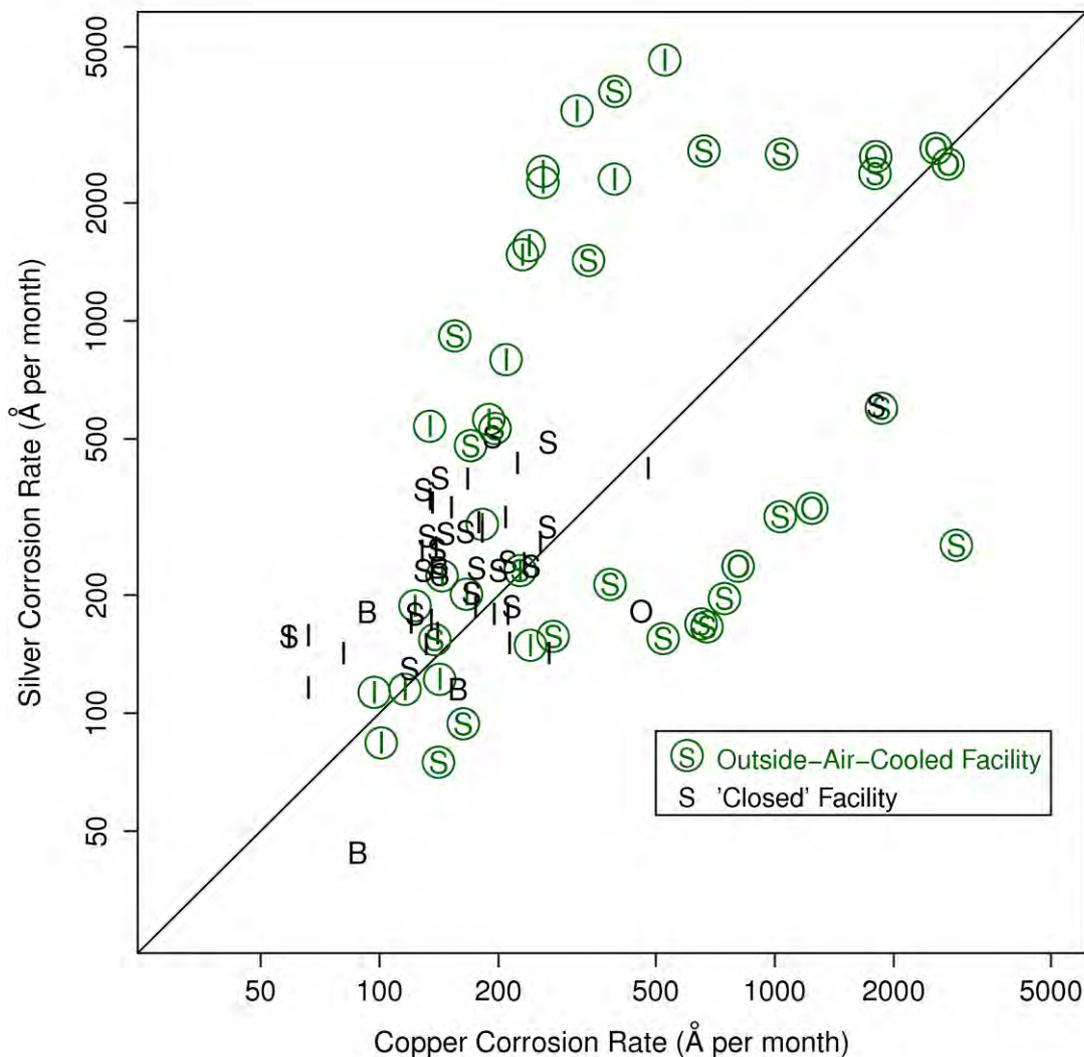
The results of analyzing the reactivity monitoring measurements from 21 data centers follow. Figure 2 shows the copper and silver measurement for all coupons used and recovered. The location type Outside, Supply or Inside is shown by letter O, S or I respectively. The “unexposed” or background measurements are indicated by “B”. The measurements from outside-air cooled data centers have a circle around the location type indicator. Observations are:

- Some measurements from coupons exposed in data centers for 30 days were below the background or unexposed coupon measurements.
- Large silver measurement ranges are associated with small copper measurement ranges.
- Large copper measurement ranges are associated with small silver measurement ranges.

Figure 2 - Measurements From All Data Centers Including All Location Categories, Measurements from Outside-Air Cooled Data Centers are Circled Background or Unexposed Indicated by “B”, Outside Indicated by “O”, Supply indicated by “S”, Inside Indicated by “I”

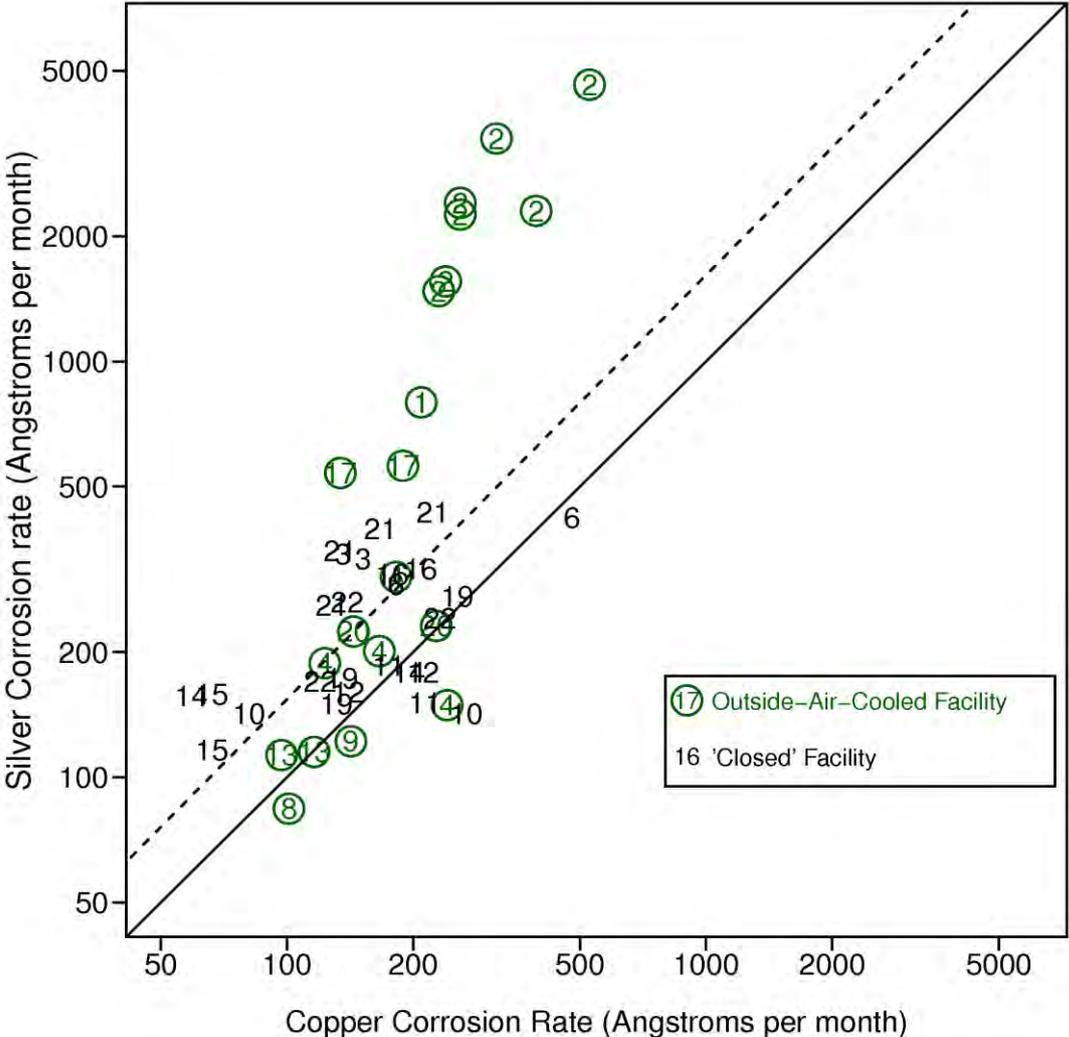
Figure 3 shows the “Inside” only copper and silver measurement for all coupons recovered. The data center identification number is plotted and indicates the measurement value for each coupon. Observations are:

- All copper corrosion rate measurements are below the levels thought to be problematic.
- The correlation between silver and copper corrosion “Inside” rate measurements is poor. The best-fit relationship is shown by the dashed line. Many points fall far off the line, implying that one cannot use a copper corrosion rate measurement to accurately predict the silver corrosion rate measurement in the same facility, or even on the same coupon. (Technical note: the best-fit power-law relationship is linear, and the silver corrosion rate is, on average, 1.4 times the copper corrosion rate. However, the value of R^2 for the fit in log space is only 0.33).
- Note: The highest 7 silver “Inside” measurements came from one (#2) United States data center.

Figure 3 - Measurements From "Inside" Only, Data Center ID Number Located to Indicate Copper and Silver Measurement For Each Coupon, Numbers are Circled for Data Centers Using Outside-Air Cooling, Data Center ID#5 was Not Assigned.

The correlation between silver and copper corrosion rate Inside measurements is poor, as can be seen in Figure 3. The correlation if all measurements location types are considered is much lower. The best-fit relationship for Inside measurements is shown in Figure 3 by the dashed line. Many points fall far off the line, implying that one cannot use a copper corrosion rate measurement to accurately predict the silver corrosion rate measurement in the same facility, or even on the same coupon. (Technical note: the best-fit power-law relationship is linear, and the silver corrosion rate is, on average, 1.4 times the copper

corrosion rate (indicated by the dotted line in Figure 3). However, the value of R^2 for the fit in log space is only 0.33).

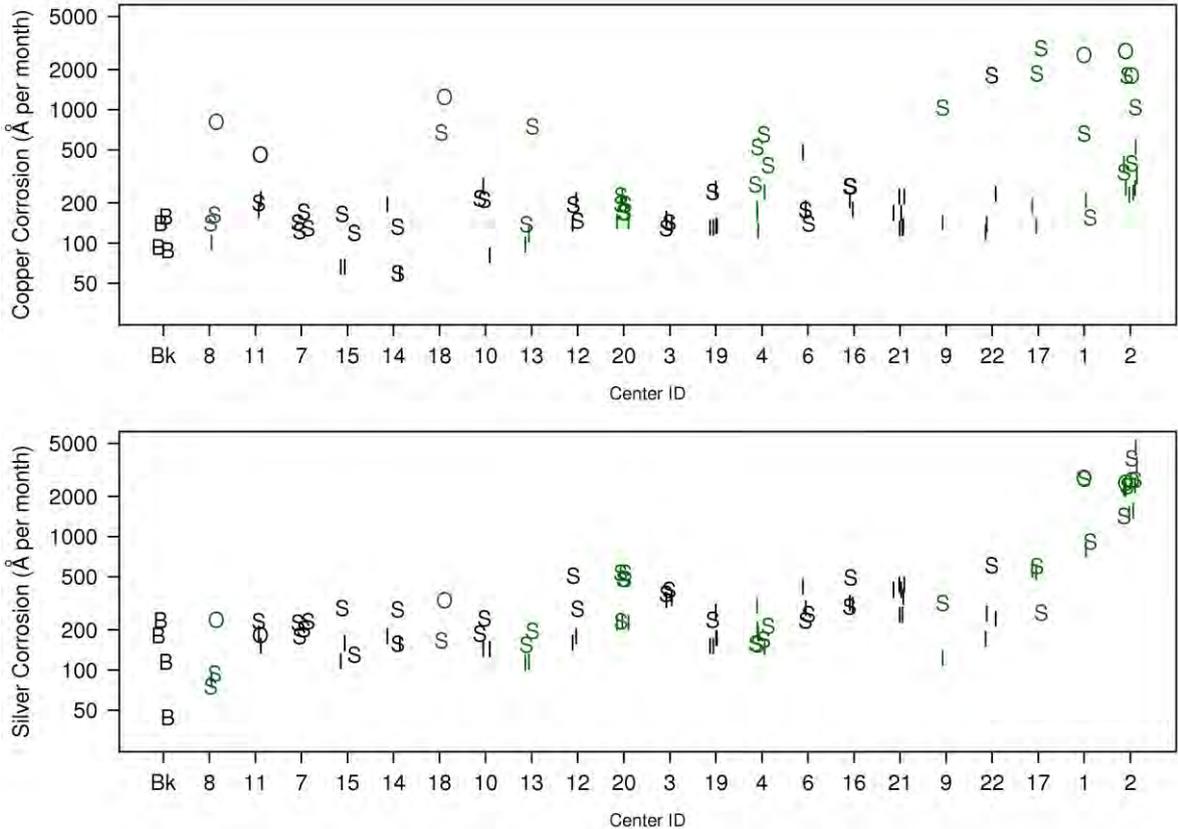
Figure 4 shows the copper and silver measurement for all coupons recovered listed by data center identification. The location type either Outside, Supply or Inside is shown by letter O, S or I. Background measurements are indicated with "B". Observations are:

- Outdoor (Outside) corrosion measurements were made at data centers 1, 2, 8, and 11. In all cases, the copper corrosion rate was much higher Outside than Inside: the ratio of average Outside to average corrosion Inside rate was 12, 7, 8, and 2.4. For silver, the ratio was 3.5, 1.0, 2.8, and 1.1.

- In 75% of data centers, the average copper corrosion rate was higher in the air Supply system than in Inside, and in half of the data centers the ratio of Supply-side to Inside corrosion rate exceeded 1.5; in 25% of centers, the ratio exceeded 2.8. Similarly, in 75% of data centers the average silver corrosion rate was higher in the Supply system than in the Inside, and in half the ratio exceeded 1.3; in 25% of centers, the ratio exceeded 1.8.

- The variation of copper corrosion rates among data centers is lower in the Inside than in the air Supply system: the standard deviation of copper corrosion rate is 63 angstroms/month in the Inside, and 590 angstroms/month in the Supply system. For silver, the standard deviations are 546 angstroms/month for Inside and 602 angstroms/month in the Supply system.

Figure 4 - All Measurements Sorted by Combined Average of Copper and Silver Measurements and Identified by a Data Center ID#, Background or Unexposed Indicated by "B", Outside Indicated by "O", Supply Indicated by "S", Inside Indicated by "I"; ID Number Does Not Correspond to Listing Sequence in Appendix A. Data Center ID#5 was Not Assigned.

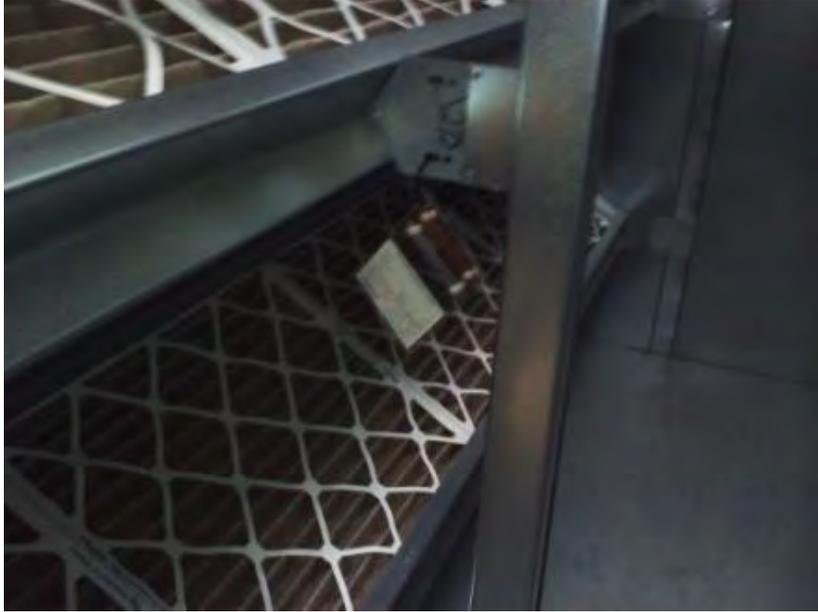
Figure 7 - Typical Coupon Mounting - Example Shown is Immediately Downstream of Supply Air Filters as Found in Large Roof Top Fan Units

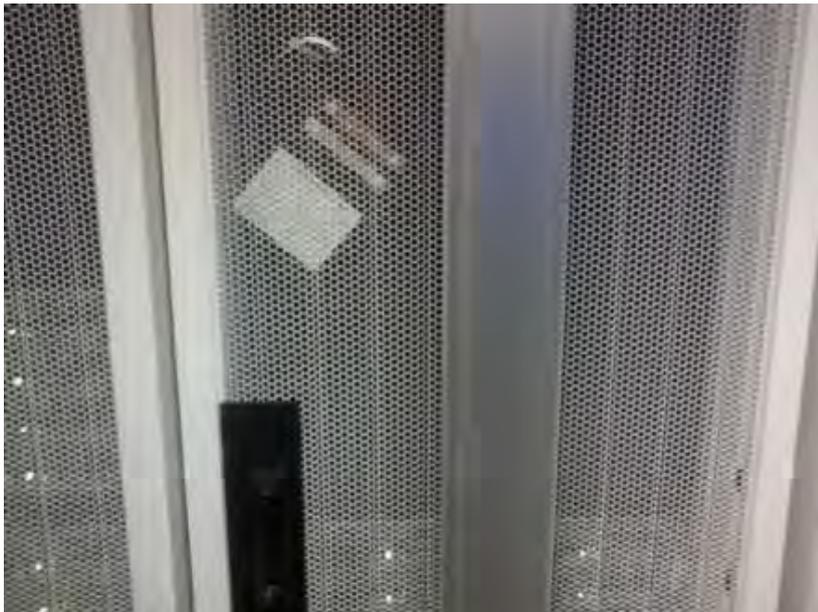
Figure 8 - Typical Coupon Mounting, Example Shown is Just Prior to Cooling Air Entering IT Equipment

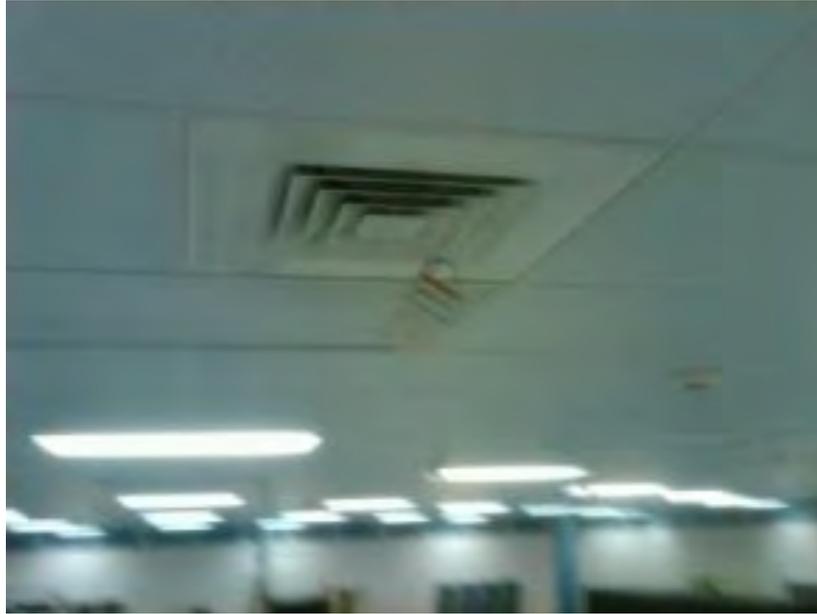
Figure 9 - Typical Coupon Mounting, Example Shown at Data Center Room Supply or Return Grill
