**Public Interest Energy Research (PIER) Program  
FINAL PROJECT REPORT**

**Air-Side Economizer Cooling Is Safe  
for Most California Data Centers**

Prepared by: Lawrence Berkeley National Laboratory

MARCH 2011  
CEC-500-2011-XXX

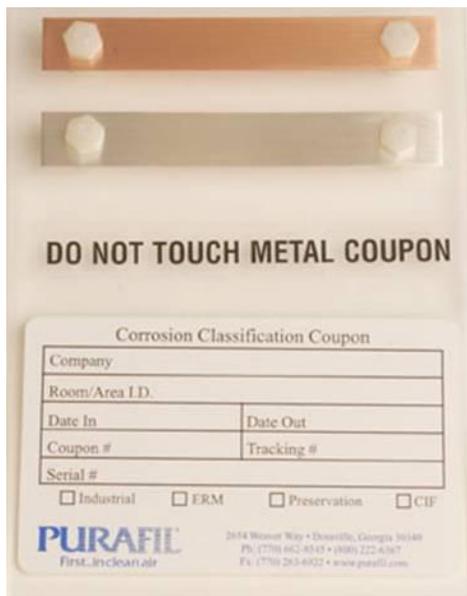
**Figure 1: Picture of an Unexposed Corrosion Classification Coupon**

angstrom angstroms (Å)/30 days. In addition the analysis can provide some information regarding what type of contaminate was the likely cause of most of the corrosion growth. Under the scope of this project, the research team was not able to analyze this information, but the data is available and this type of analysis is recommended for future studies. Each coupon set (copper and silver) is attached to a Plexiglas support (approximately 4" x 3" x 1/4") and coupon number, date, and location information recorded on the transmittal label (Figure 1). In order to minimize any background corrosion, coupons are provided packed in a zip-lock plastic bag with a Purafil Sachet that acts as a scavenger for any ambient contamination that may have been sealed inside the bag with the coupon. After the exposure period the coupons are repackaged in the original plastic bag with the Sachet and returned for analysis. See **Figure 1** showing a photograph of an unexposed corrosion classification coupon.

The standard method for analyzing corrosion coupons is called cathodic/electrolytic reduction. The thickness of the corrosion film is determined by Purafil's laboratory analysis. The results included with each coupon report contain a photograph of the returned coupon, ISA Environmental Classification, and film thickness/30 days.

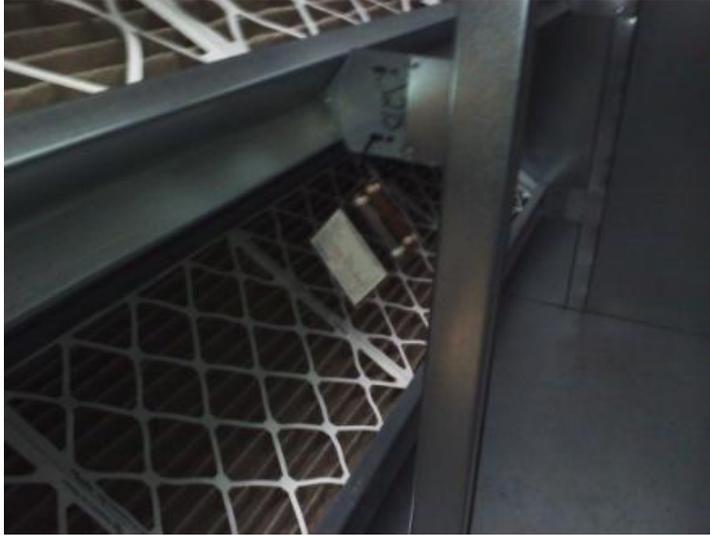
**Figure 4 - Typical Coupon Mounting - Example Shown at Supply Air Filters as Found in Large Roof Top Fan Units**

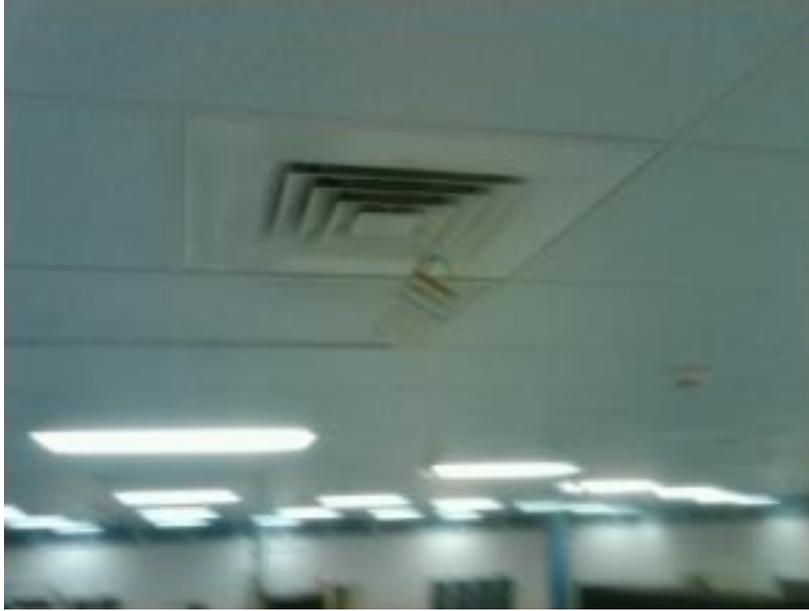
**Figure 6: Typical Coupon Mounting, Example Shown at Data Center Room Supply or Return Grill**
